Manhole Inspection Summary

Manhole # S47CC_028MH

Insp Date: **2/4/08 11:46 AM**

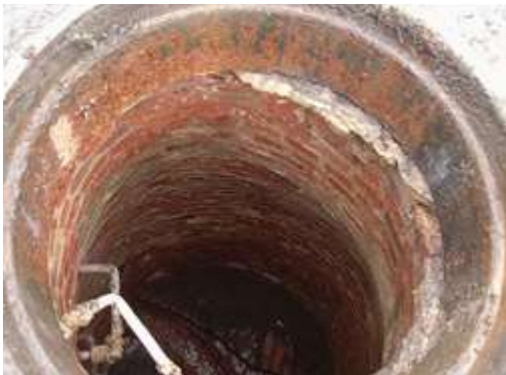
Defect 1

Condition: ☐ Sound ☐ Cracked ☐ Root Intrusion ☐ Loose Brick ☒ **Deteriorated**

Infiltration: ☐ None ☐ Joint ☐ Cracks ☐ Mortar ☐ Roots ☒ **Wall**

Deterioration

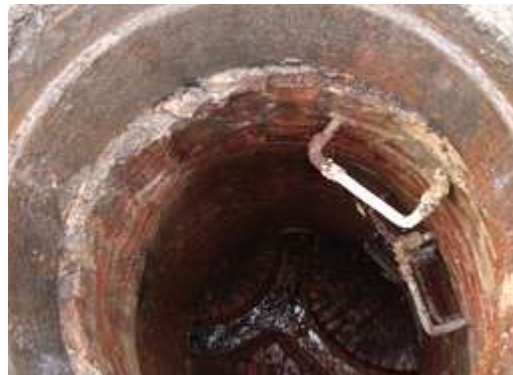
Defect 2

☒ **Leaks**

Frame Leaks

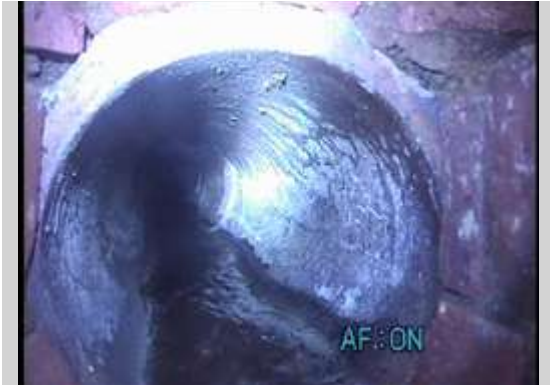
12 O'Clock Outflow

8 in. Circular Gravity Sewer
Pipe Out @ 12 O'Clock

Pipe Height: **8.4** (in.) Rod and Bar (Angled)
Pipe Material: **Clay** ☐ Pipe Lined
Invert Depth: **10.00** (ft.) Flow Characteristics: **Fast**
Deposits: ☒ None ☐ Mud ☐ Sludge ☐ Debris ☐ Grease
Silt Depth: (in.) Deposits Extent:
Infiltration: **None** Pipe Seal Cond: **Sound**

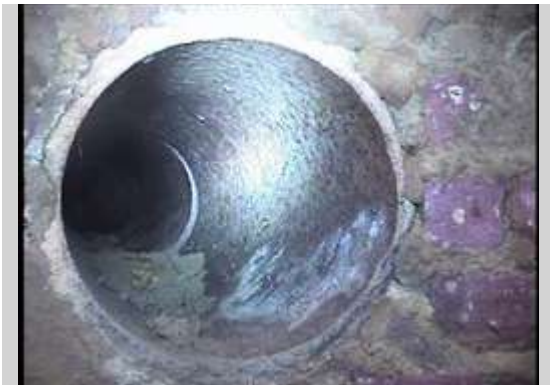
3 O'Clock Inflow

8 in. Circular Gravity Sewer
Pipe In @ 3 O'Clock

Pipe Height: **8.4** (in.) Rod and Bar (Angled)
Pipe Material: **Clay** ☐ Pipe Lined
Invert Depth: **7.65** (ft.) Flow Characteristics: **Fast**
Deposits: ☒ None ☐ Mud ☐ Sludge ☐ Debris ☐ Grease
Silt Depth: (in.) Deposits Extent:
Infiltration: **None** Pipe Seal Cond: **Sound**

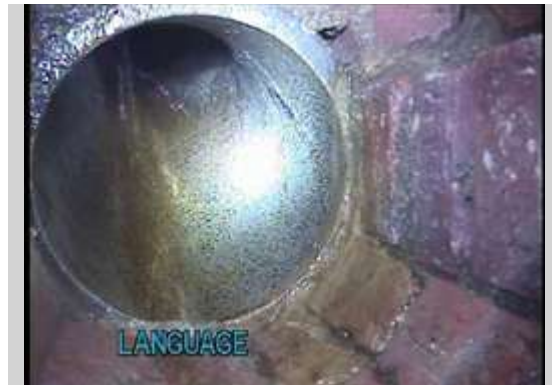
Drop In @ 3 O'Clock

Drop: **Outside** Rod and Bar
Angled: **Yes** Reading: **8.80** (ft.)
Inv Depth: **9.80** (ft.)

Drop Condition: **Open**

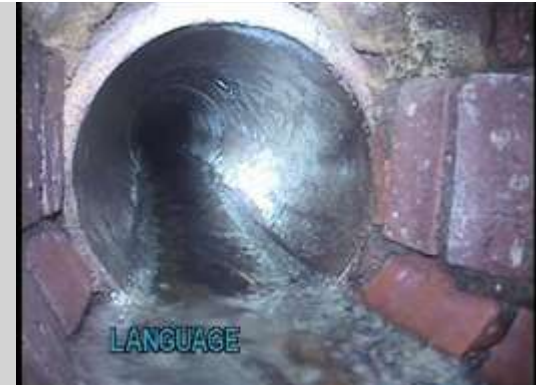
9 O'Clock Inflow

Pipe In @ 9 O'Clock

Pipe Height: **7.2** (in.) Rod and Bar (Angled)

Infiltration: **None** Pipe Seal Cond: **Sound**
